# ASSESSMENT OF RIVERBED EROSION PROCESS OF MIDDLE ODRA RIVER ON MALCZYCE–ŚCINAWA SECTION

WŁODZIMIERZ PARZONKA

### Ryszard Kosierb

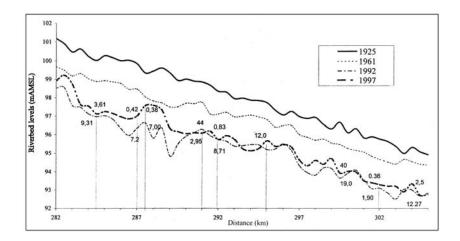
It must be mentioned here, however, that the measurements in 1997 were taken after the July flooding, which caused considerable deformation of the Odra River streamway and disturbed the formerly settled conditions of the bed load flow (figures 1 and 2).

Fig. 1. The alteration in the diameter  $d_{50}$  of the bed load in 1996 and 1997 against the background of longitudinal profiles of the Odra River, section Brzeg Dolny–Malczyce

For the section between Brzeg Dolny and Ścinawa, a comparison was made to show the change in the graining of bottom material collected in 1996 and 1997 in the longitudinal profile of the Odra River. The characteristic values of the grain diameter  $d_{50}$  were marked on the diagrams of longitudinal profiles (figures 1 and 2). Along a several-kilometre Odra River section, from Brzeg Dolny to the 290<sup>th</sup> km, where the bottom rose distinctly after the flooding in 1997 in comparison with the year 1992, the size of an average grain decreased significantly, from 9.31 mm to 3.61 mm (285<sup>th</sup> km) and from 7.22 mm to 0.42 mm (287<sup>th</sup> km). Down below that section, despite the potholes and outwashes occurring interchangeably, the proportion of thicker particles decreased. Only at the 295<sup>th</sup> km the Odra River bottom made of clay was covered by non-cohesive material ( $d_{50} = 12$  mm). At the 300<sup>th</sup> km, in turn, the covering bottom material thickened (the diameter  $d_{50}$  increased twice).

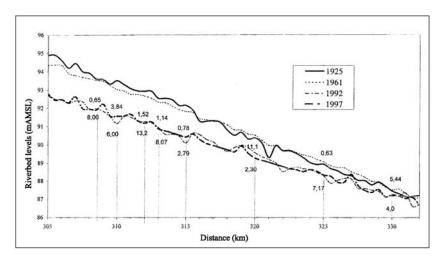
Fig. 2. The alteration in the diameter  $d_{50}$  of the bed load in 1996 and 1997 against the background of longitudinal profiles of the Odra River, section Brzeg Dolny–Malczyce

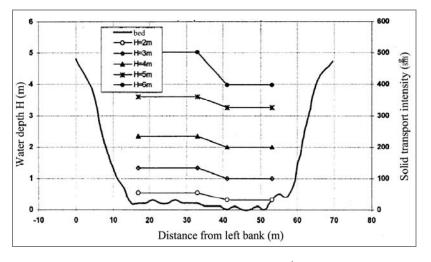
Fig. 3. The Odra River cross-section at the 302<sup>nd</sup> km (Malczyce)

The analysis of the Odra riverbed geometry, together with the measurement of bed load transportation, on the section under investigation shows that the width of the strip of the rubble traction changes from 40 m to 60 m and its mean value equals 50 m. On the basis of the analyses carried out as part of [1] and [7], as well as the assessment prepared by the ecologists [13], it was assumed that the river bottom should be raised by at least half the value of its lowering in recent years, by means of filling it up with

the rubble of suitable granulation. Figures 3 and 4 display sample geometry of the Odra River bed at the  $302^{nd}$  and  $332^{nd}$  km, as well as some characteristics of the bed load transport intensity.

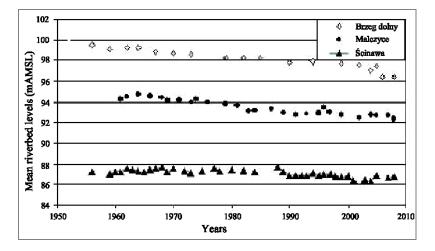
Fig. 5. Changes of the riverbed bottom's datum  $T_{\rm av}$  (m AMSL) at the river gauging stations of Brzeg Dolny, Malczyce and Ścinawa according to the Institute of Meteorology and Water Management in the years 1956–2008

Table 3 and figure 5 imply that in the period of 1956–2008 the bottom  $T_{av}$  lowered at particular river gauging stations in the following way:

- in Brzeg Dolny from 99.49 m AMSL to 96.39 m AMSL, i.e. by 3.10 m,
- in Malczyce from 94.41 m AMSL to 92.37 m AMSL, i.e. by 2.04 m,
- in Ścinawa from 87.20 m AMSL to 86.72 m AMSL, i.e. by 0.48 m.
