EXAMPLE BUILDING DAMAGE CAUSED BY MINING EXPLOITATION IN DISTURBED ROCK MASS

LUCYNA FLORKOWSKA

The Strata Mechanics Research Institute of the Polish Academy of Sciences,
ul. W. Reymonta 27, 30-059 Kraków, Poland.

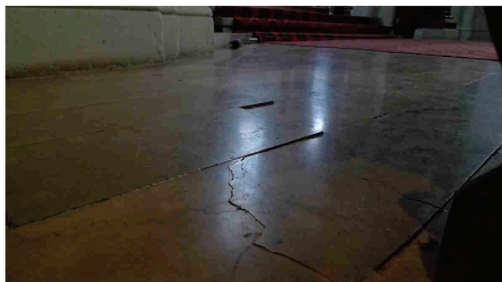
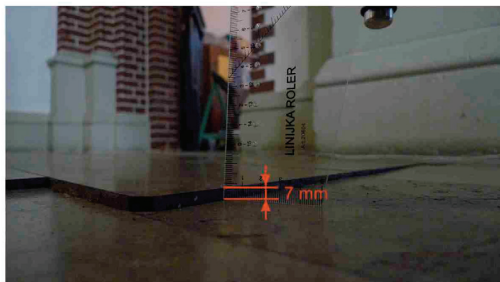
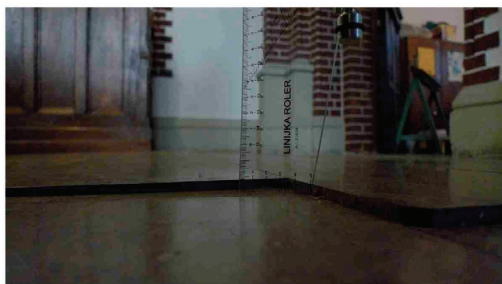
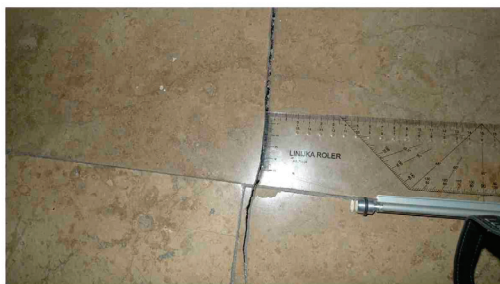
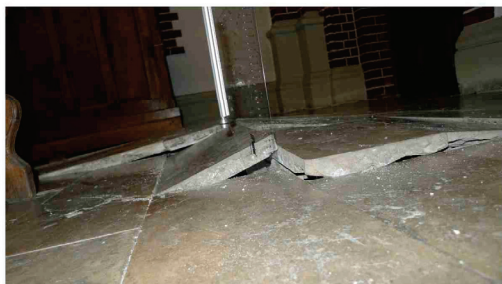
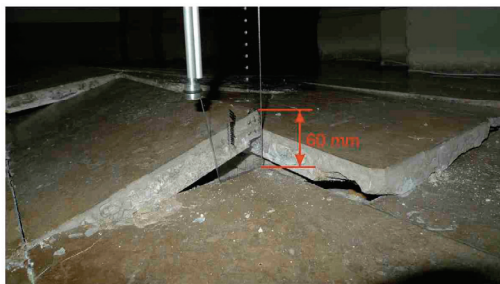
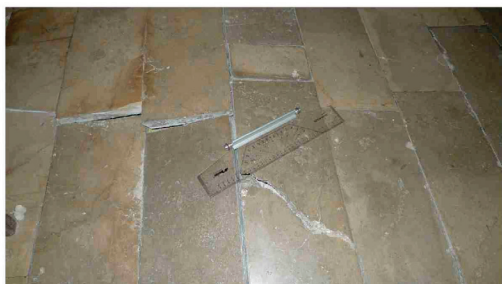
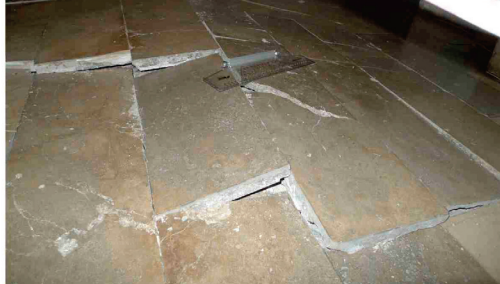
Fig. 9. Damaged church floor

the state prior to December 9, 2012 (fot. 02-12-2011 r.)

the state after 9 December 2012 (fot. 5-01-2012 r.)

the longwall 18a/bed 510wd is being mined, which progresses from South to North. Despite longwall face being beyond the reach of major influences (as on January 2012), both the building and its surrounding show worrying deformation and damage. The church's floor made of stone plates became unevenly deformed. There are considerable floor bulges in the aisle located in the Northern part of the church. Evident were also cracks and vertical displacements of tiles. The condition of the building significantly worsened as of 9 December 2011, when the floor abruptly elevated and shattered with acoustic effects accompanying. Figure 9 illustrates a comparison between the state of the floor from 2 December when property condition was surveyed and its state after the abrupt event.

Cracks in the floor have also surfaced in other parts of the church. The crevice above the alter becomes ever-more evident. The line demarcating change in the slope of church's body also runs through that point. Said line seems "broken" along the wall parting presbytery and main nave. Vast cracks in the vault are also visible there, which lately (about 5 January 2012) increased enough for the rain water to leak in and drip on the altar's steps. This is indicative of sheet metal roof also becoming damaged. Figure 10 illustrates said damage. The stack partition, which is under shear stress becomes alarmingly deformed. The photograph shows major displacement of bricks composing stack partition, both in the loft and exterior wall – Southern elevation.

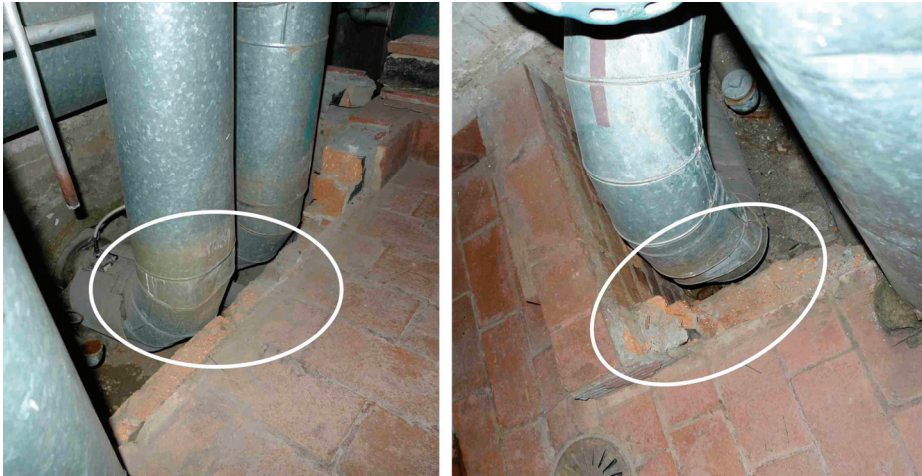
Fig. 16. NH boiler room. Visibly bent pipes and incuts made to protect the piping from damage
