MICROSTRUCTURAL AND TOMOGRAPHIC ANALYSES IN GEOTECHNICAL ASSESSMENT OF SOIL MEDIA

MACIEJ KORDIAN KUMOR

University of Technology and Life Sciences, Geotechnical Department, Bydgoszcz, Poland,
e-mail: maciej.kumor@engeo.com.pl

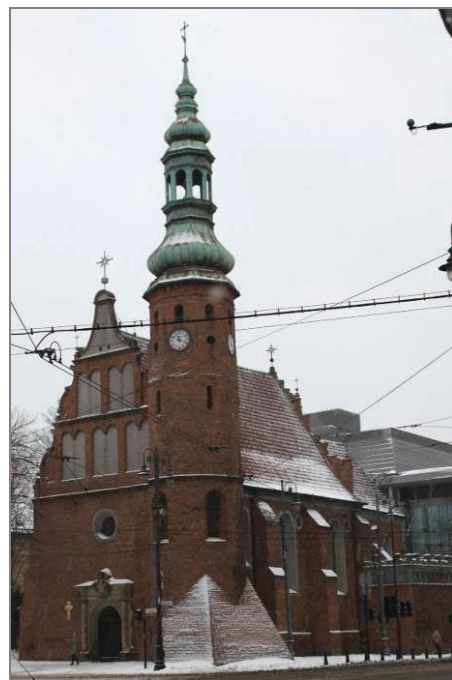
Fig. 1. A general view of the damaged object, March 2013

As it is assumed, because of deep excavations conducted since 2005 in the vicinity of the church subsoil, stability was disturbed and dangerous fracturing was observed in that object. After analyses of the structural damage the object was classified as 1° failure [5]. In walls marked concentration zones of cracks of various width and single cracks of 5 to 15 mm in width were observed, running from the foundation and expanding upwards. Problems appeared, such as doors and windows that could not be opened or closed, tilting ceilings, breaking window panes, detached stairs and annexes, etc. (Fig. 1).

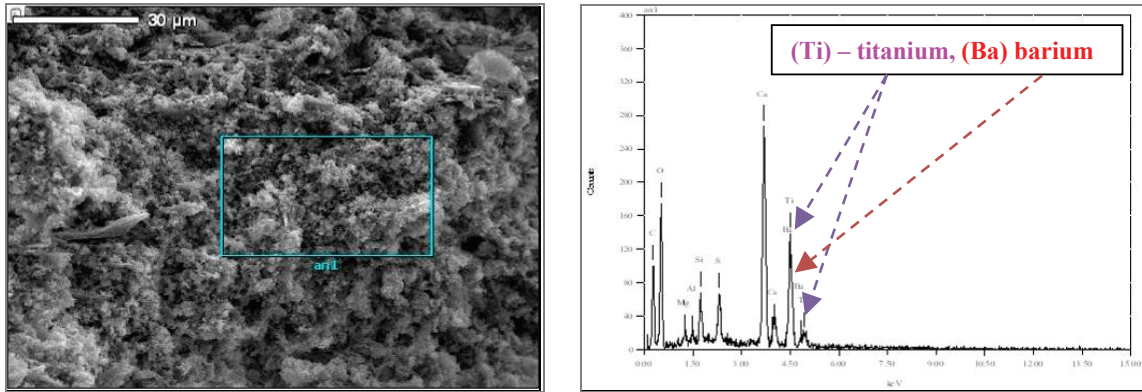
Fig. 4. A microphotograph of surface of damaged plaster with EDS spectrum of chemical composition of contamination with titanium paints (titanium Ti compounds, walls painted in 1936, barium Ba – painted in 1903)

The following findings result from the analysis of microphotographs of damaged plaster surface (Fig. 4), as well as EDS spectra for contents of individual elements and the chemical composition of paint pollutants:

- The occurrence of elements contained in paints used on walls, i.e., titanium and barium;

An increase in carbon contents indicates the deposition of such gases from air as CO and CO₂, which cause leaching and softening of the mortar structure. The occurrence of titanium and barium is connected with the fact that damaged fragments were previously painted (in 1903 and 1936, when paints for outdoor use were based on minerals, barium and titanium). A high sulfur content is caused by its deposition from gases, SO₂ and SO₃, causing sulfur corrosion, resulting in the formation of, e.g., ettringite (Fig. 7).

Summing up the results of SEM and EDS analyses based on the microanalysis presented in Fig. 4 it may be stated that the analysed crack-fracture is an old case of damage, dating back to over 100 years.

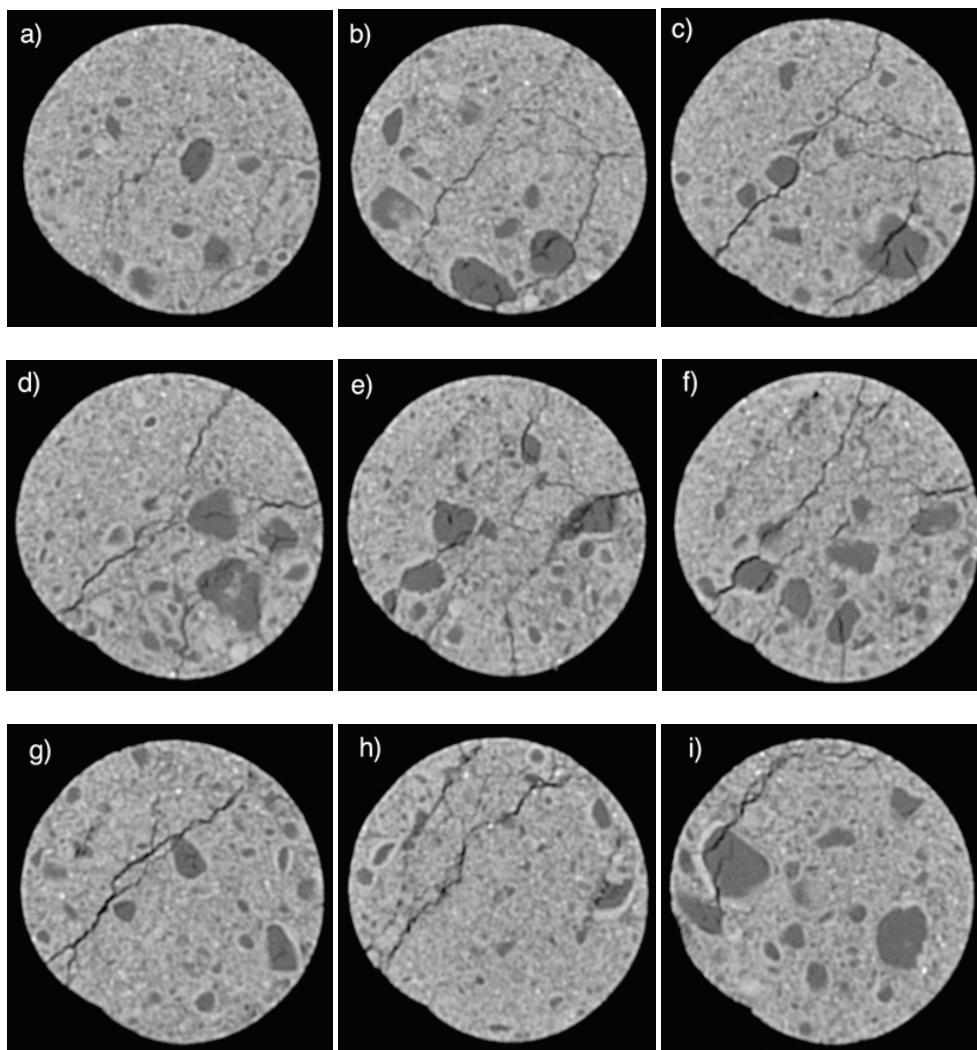
Figure 10 presents selected structural cross-sections of sample K1. We may observe a heterogeneous structure with a marked random concentration of microaggregates of organic matter in the sample mass. The fracture developed in the weakest zone, the concentration of organic matter, which was tracked downwards starting from the top (a) to approx. mid-height of the sample (i). General observations indicate regularities in the development of sample destruction zones. The location and range of shear surface are dependent on the accumulation of microaggregates of organic particles in the composite. This is particularly evident in Figs. 10 b, c and f, where microfractures

Fig. 10. Analysis of selected cross-sections of composite K1

are initiated. The shear surfaces unfold the destruction path further through natural weakenings, i.e. organic microaggregates (visible in photographs as darker clusters). This is consistent with the fundamental principle of mechanics, i.e. the principle of least action or Hamilton's principle [8]. This confirms and directly illustrates the significant effect of component homogenisation on the final strength of the composite and justifies the application of CT in its assessment.

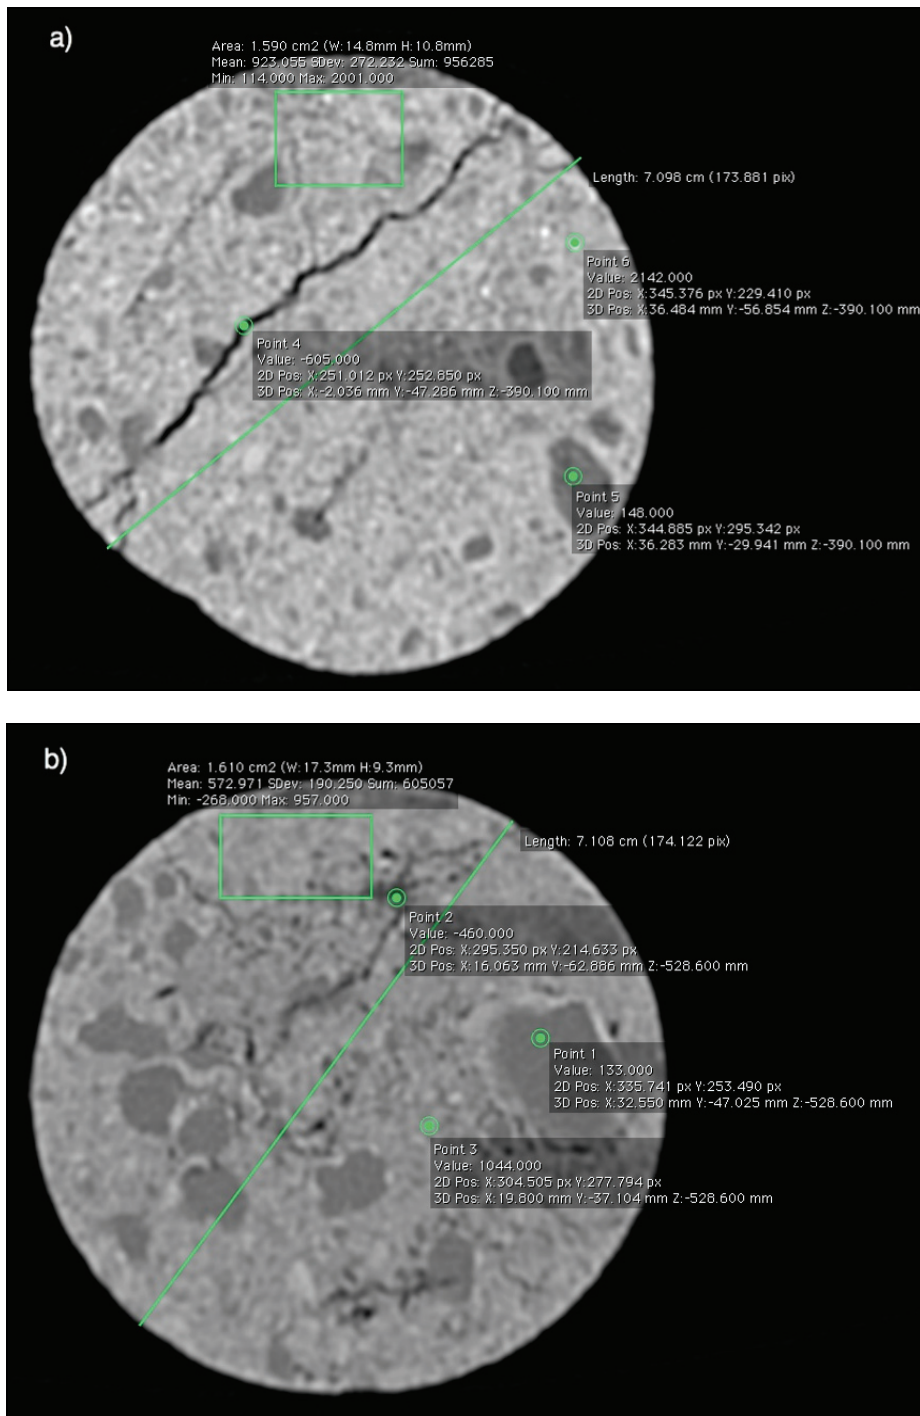
Fig. 12. Application of the ROI function in the analysis of example sections of composites: (a) K1, (b) K2

such as determination of absorption coefficient of a point as well as a marked arbitrary area. It is also possible to magnify the selected area, its dimensioning and many other functions. Below we compare example sections of composites K1 (Fig. 12a) and K2 (Fig. 12 b). Analysis of images indicate a considerably greater density of composite K1 (the greater value of radiation absorption, the lighter the colour in the grey scale). A markedly greater porosity of com-

posite K2 was observed in relation to K1. Analysis of selected rectangular ROI (denoted as *Area*) shows a mean HU for K1 (approx. +923) to be almost two-fold greater than K2 (approx. +572), as it could have been expected. A markedly greater maximum value of HU (approx. +2001) in composite K2 is connected with the occurrence of quartz sand grains. All pores, air-filled fractures, should have a negative value in the HU scale, e.g., point 4 in Fig. 12 (a) or point 1 in

Fig. 12 (b). Organic substance takes much lower values in analysed sections from +133 for K1 to +148 for K2 in the HU scale.
