TECHNICAL NOTE

EXAMPLE OF THE APPLICATION OF JET GROUTING TO THE NEUTRALISATION OF GEOTECHNICAL HAZARD IN SHAFT STRUCTURES

PIOTR DYBEL, DANIEL WAŁACH, JUSTYNA JASKOWSKA-LEMAŃSKA

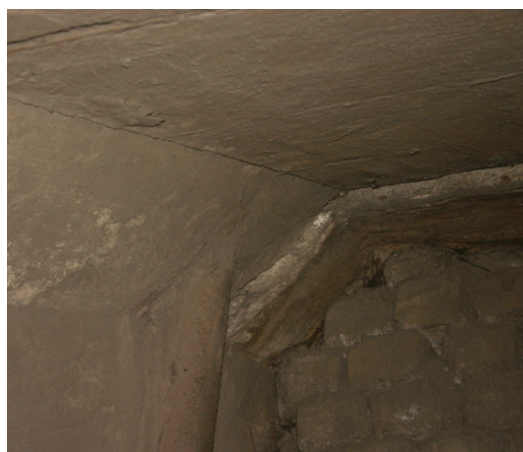
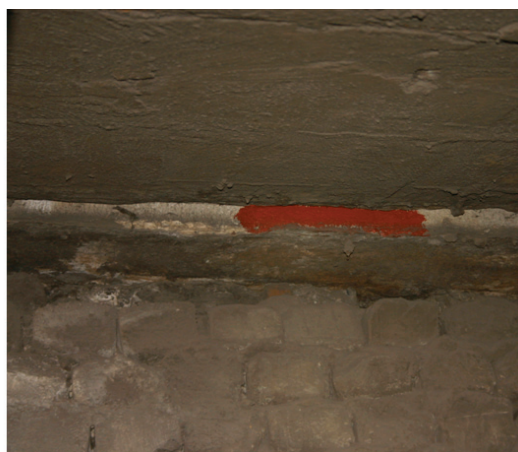
After the dislocation of the ventilation duct, a site inspection was performed, including the immediate area around the shaft, ventilation duct and the shaft top building. As a result of the displacement of the first segment of the ventilation duct in relation to the shaft collar, a possibility of additional loads affecting the shaft lining was found. These loads were not taken into account in the initial design. The research conducted by the authors included the analysis of the current condition as well as control static and strength calculations helped to assess the real hazard to shaft structures and infrastructure. It was shown that further subsidence of the ventilation duct may lead to damaging the shaft structures. Immediate protection of the

Fig. 2. Vertical displacement on the joint of the L-1 segment of the ventilation duct with shaft collar, from the shaft's side

ventilation duct against further subsidence was recommended [2].

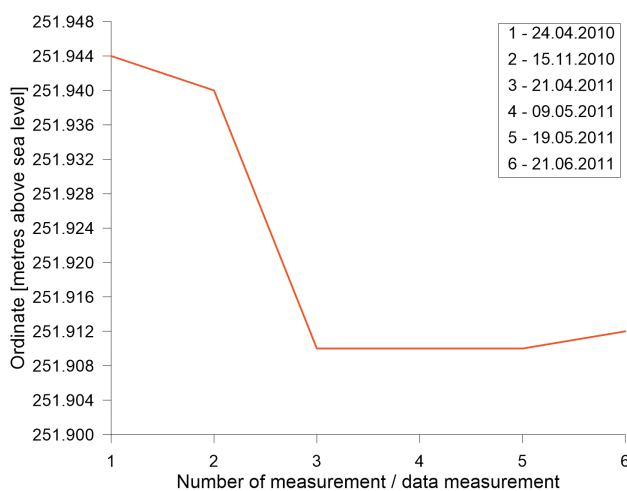
Fig. 3. Measurement point levels in the L-1 segment of the ventilation duct

placement in the period from November 2010 to April 2011 was 3.1 cm. The analysis of the surveys also shows that the subsidence process was most intensive in the spring of 2010 (Fig. 3).

The results of geodetic surveys show that the factors contributing to the displacement of the segments of the ventilation duct have stabilised. However, due to the geotechnical conditions, further subsidence cannot be excluded.

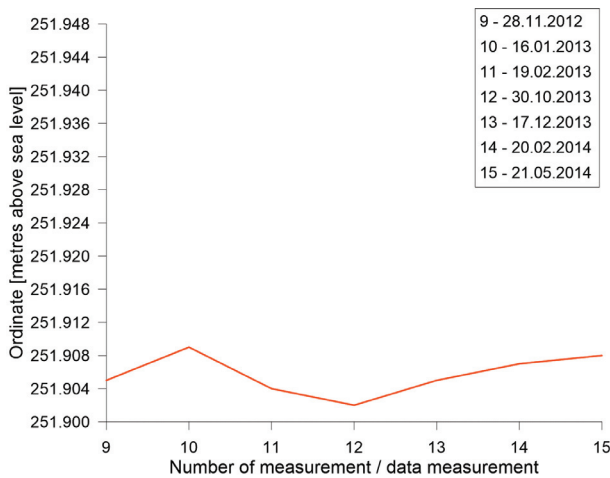
the ventilation duct. Similar dependences were found for the remaining measurement points.

Fig. 5. Measurement point levels in the L-1 segment of the ventilation duct after the reinforcement of the foundation soil
