The Consequences of Non-Uniform Founding of Concrete Tank in Weak Wet Subsoil

Abstract: The article presents problem of non-uniform foundation of structures in weak wet subsoil. The problem is illustrated with the case study of two-chamber-reinforced concrete water tank constructed in 1920s of 20th century, which cracked during construction. Under part of foundation, where the peat was found, the concrete piles were introduced.

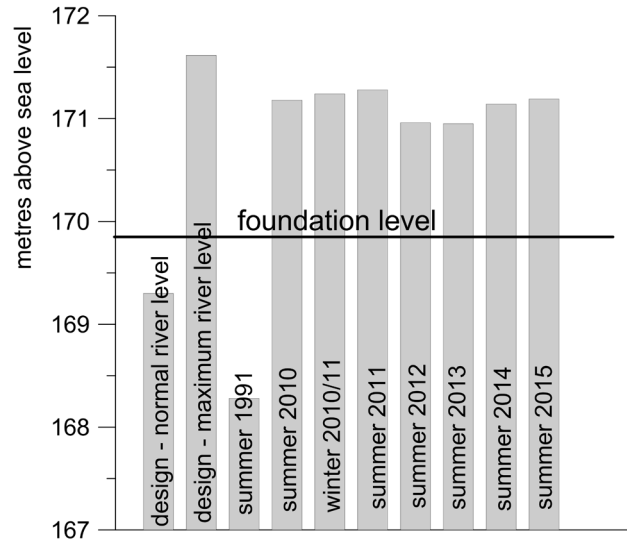
The underground water level has changed since the years. During geotechnical testing in 1991, the underground water level was stabilised from 167.27 up to 168.29 m above sea level. Therefore, it was more than 1 m lower than that of tank foundation. Meanwhile, in 2000, in the place of bottom slab depression inside the tank, two holes were found, from which the water came out to the surface under pressure. This indicated the rise of underground water level. What is more, the water appeared in the adjacent pump station, also proving the underground water level rise. In the spring of 2010, the owner started the piezometric measurement of underground water level (Fig. 5).

Figure 5: The levels of underground water in relation to foundation level: the water in the river in accordance to design drawings (normal and maximum) and the water level found nowadays (maximum).

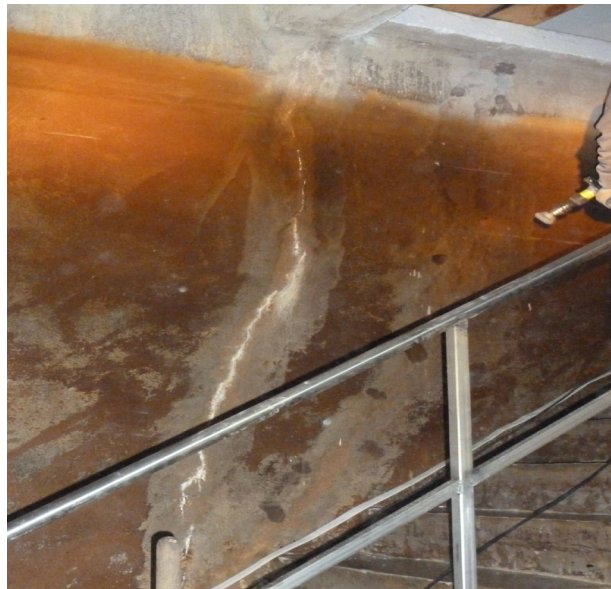
Figure 6: The exemplifying crack with salting out in the longitudinal partition wall.

Several cracks were repaired. The most of them remains closed, but in some of them, in the longitudinal partition wall, the secondary cracking and salting out appeared.

allowed but the repair works were recommended. The injection of cracks with elastic material dedicated for open movable cracks was recommended. This ensures the tank water tightness as well as further movement of separated parts in relation to each other without waterproofness loss.

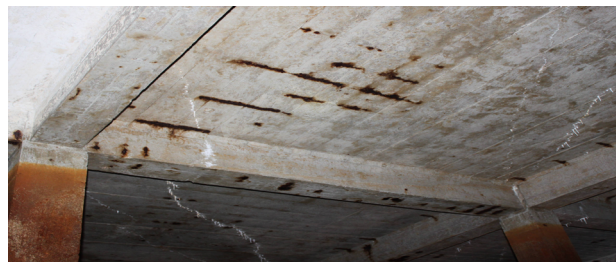
- intensive cracks in the roof slab in chamber No. 1, inclined in relation to wall axes at an angle of 45°; some of them propagate into beams or longitudinal

Figure 7: The exemplifying crack with stalactites of salting out in the roof slab.

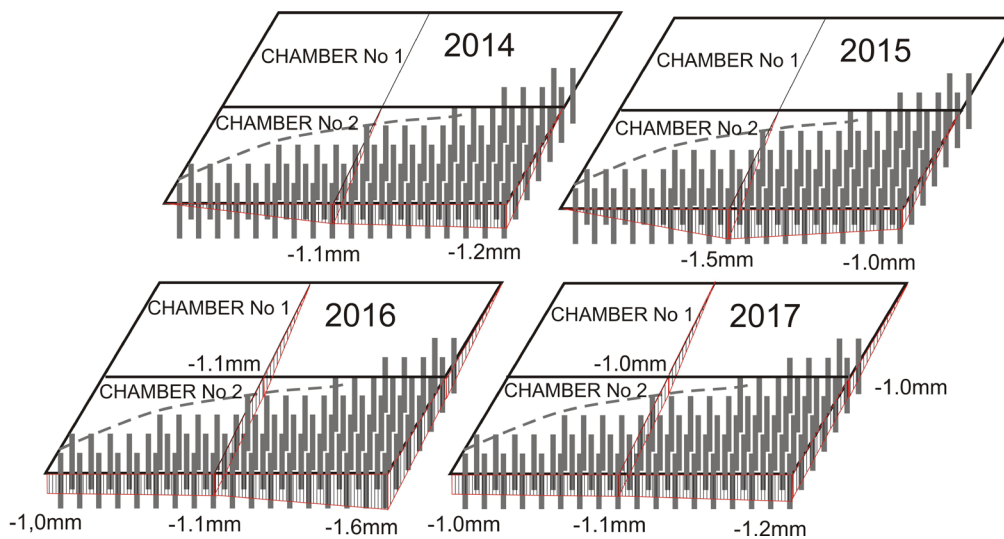
The five-year levellings revealed movements of some controlled points; however, their displacement did not exceed 1.6 mm. Nevertheless, the movement of controlled points located along the axis of outer longitudinal wall of Chamber No. 2 (point No. 3, No. 6 and No. 9) was confirmed. Such conclusion was derived based on the accuracy of the displacement estimation (in various epochs of measurements, levelling accuracy ranged from

0.2 to 0.7 mm, depending on the measurement conditions) and confirmed by the ratio of the displacement (dH) to the error (σ_{dH}) - $|dH/\sigma_{dH}| \in (2.1;5.7)$. The control points along the longitudinal partition wall (point No. 5 and No. 8) as well as control points along the outer wall of the Chamber No. 1 (point No. 1, No. 4 and No. 7) showed the movement considered as negligible ($dH/\sigma_{dH} < 2.1$). This observation connected with small absolute displacement $|dH| < 0.5 \text{ m}$ proves that these points are stable. Non-zero values of their displacement may be considered as the effect of the measurement inaccuracy, however, being within the limits of the average error of a single observation.

that point No. 2 goes down to -1.0 mm . This suggested that this point also belongs to the zone subjected to the settlement.

The results of tank vertical movement estimation may be recapitulated as follows. There is a trend of the vertical displacement of some controlled points in relation to the initial position. There are minor but clear changes. The changes in position of point No. 3, No. 6 and No. 9, located along the axis of the outer longitudinal wall, were revealed in all the measurements.

Figure 14: Displacement of controlled points.
