CONDITIONS OF PROPER INTERACTION OF LOW-PRESSURE INJECTION PILES (LIP) WITH STRUCTURE AND SOIL, CARRYING CAPACITY OF PILE ANCHORAGE IN FOUNDATION

HENRYK PACHLA

Key words: low-pressure injection piles, pile anchorage in foundation, contact surface, foundation design

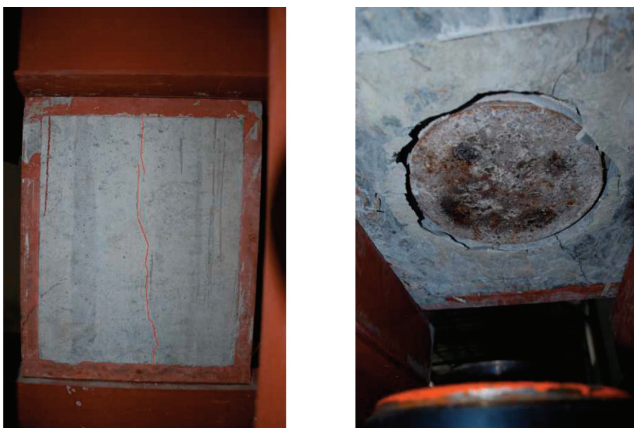
Photo 1. Specimen cracking and pulling the pile out of specimen

The form of damage was the same in all seventy specimens. In Photo 1, cracking of a specimen and pile dislocation are shown after the load reached the value which caused pulling the pile out of specimen. Photo 2 presents the form of damage after the reinforcement is

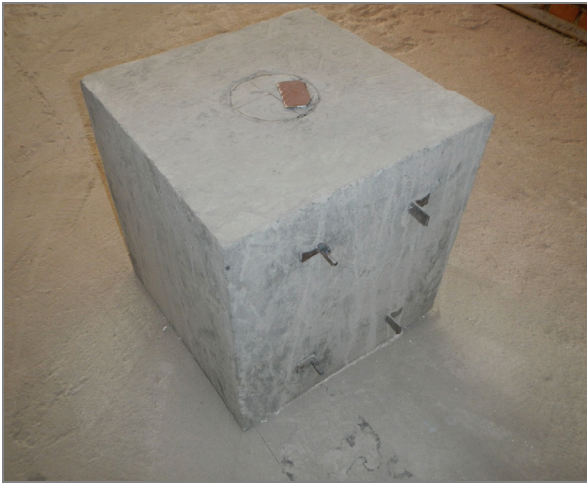
Photo 3. Specimen modelling foundation made of concrete

concrete class C12/15 which was delivered from a concrete plant. In both concrete and masonry specimens, after curing 150 mm-diameter holes were drilled (Photos 3, 4). Piles of this diameter are commonly used to strengthen the foundation, hence this hole diameter was selected. In drilled holes, piles were formed. Inside the holes piles reinforced with four bars 14 mm in diameter were installed. Round plain steel stirrups 6 mm in diameter were spaced every 20 cm. The piles were made from cement grout of w/c ratio of 0.5, on the base of cement CEM II/B-M(V-LL)32,5 R, from Rudniki cement factory.

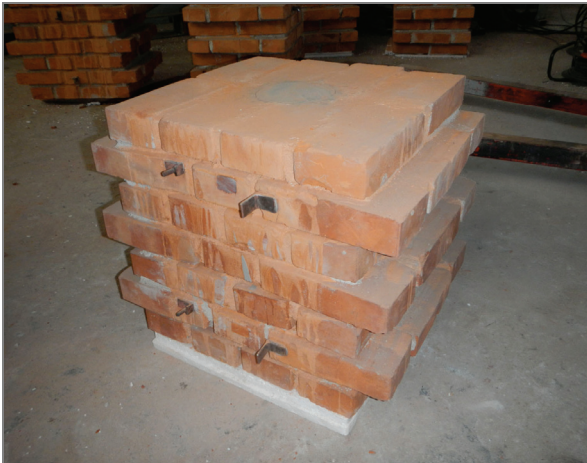
Photo 4. Specimen modelling foundation made from brick

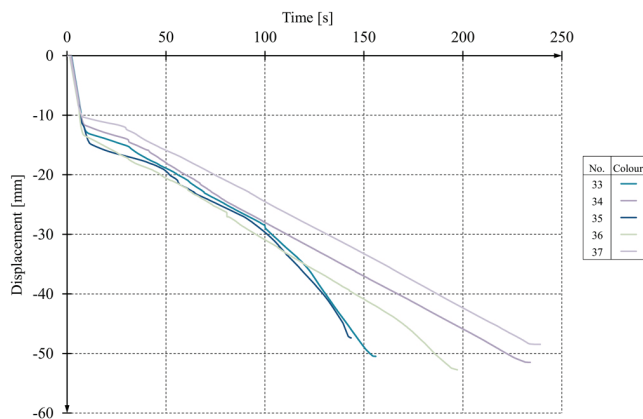
Fig. 6b. Changes of displacements of piles heads in brick specimens

Failure propagation process, and in consequence macrocracks and failure of elements made of brittle materials such as concrete, brick, mortar and grout are highly dependent on the loading application program. In the tests, loads were applied using hydraulic jacks with a given initial velocity of the piston. Different resistances of specimens and characteristics of hydraulic jacks used in experiments accounted for the displacements of the pile head. The displacements of pile heads measured during the tests on individual concrete specimens are shown in Fig. 6a. Figure 6b illustrates real displacements of piles heads for five selected specimens modelling brick foundation.

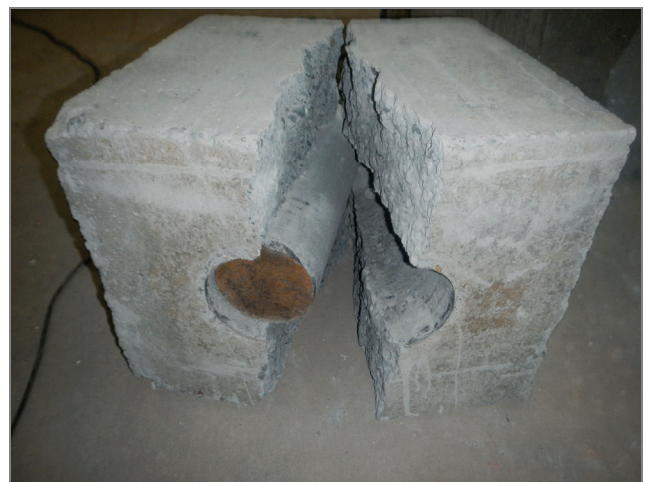
Photo 9. Pile after concrete specimen failure

intact (Photo 9). In masonry foundations horizontal cracks form, overlapping the periodic structure of brick layers and mortar (Photo 8). This effect is a result of different adherence and deformability of bricks and mortar pre-bonded with the pile.

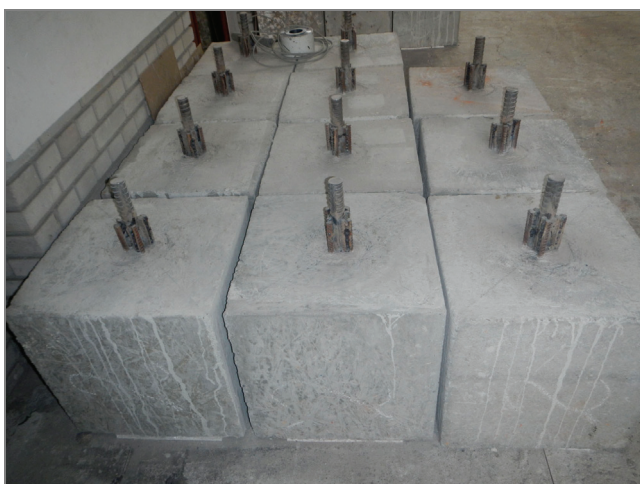
Photo 11. Test specimens modelling concrete foundations

In both masonry and concrete specimens after the curing period holes were drilled through foundation using a 150 mm diameter core. In the holes piles identical as in the case of pushing the pile into the foundations were installed but tips of SAS system thread bars were welded between the rebars to execute a force pulling out the pile (Photos 10, 11).

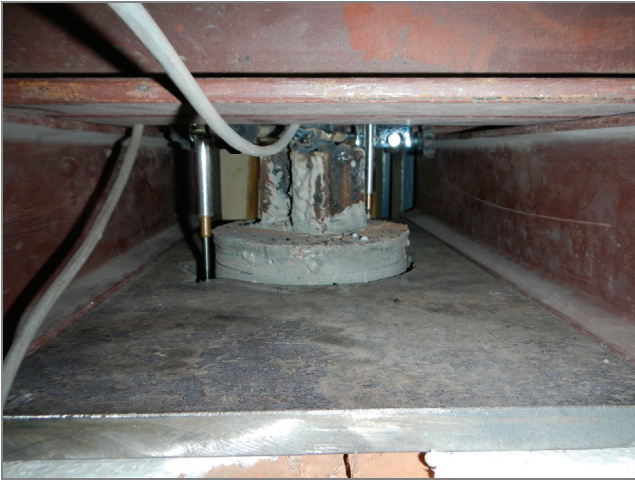
Photo 12b. Displacement of pile head in brick foundation specimen

surface increases and, as a result, the pile slides out of the part of the specimen modelling the foundation (Photos 12b, 13).

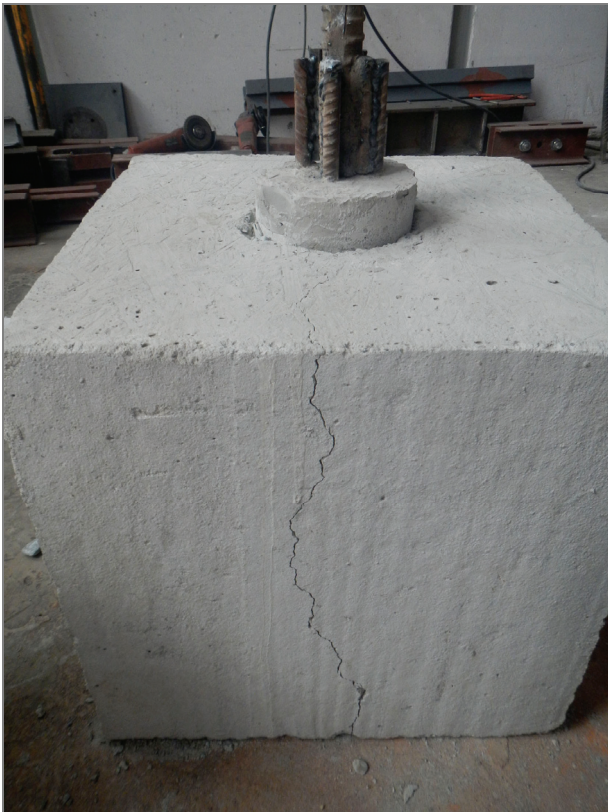
Photo 13. Concrete foundation specimen after the test

The final effect is the formation of macrocracks and fractures on the external surfaces of specimens (Photos 12a, 13). The force that can be transferred by the contact surface decreases rapidly and scatter of the test results is the highest. Similarly, this effect is accounted for by the non-uniform microdamage propagation, different intensity of microcracks development and their distribution in the area tested.

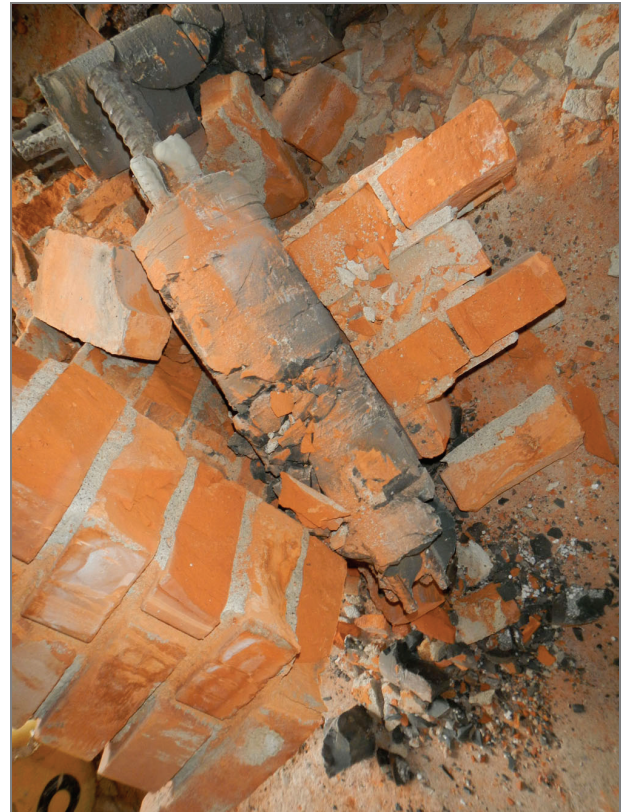
Photo 14. Damaged masonry foundation specimen

The form of failure of all specimens during pullout tests was the same as in push-in tests. The foundation section of specimens cracked and the piles were dislocated from the specimens (Photos 14, 15).
