Research Article

Concrete surface evaluation based on the reflected TLS laser beam's intensity image classification

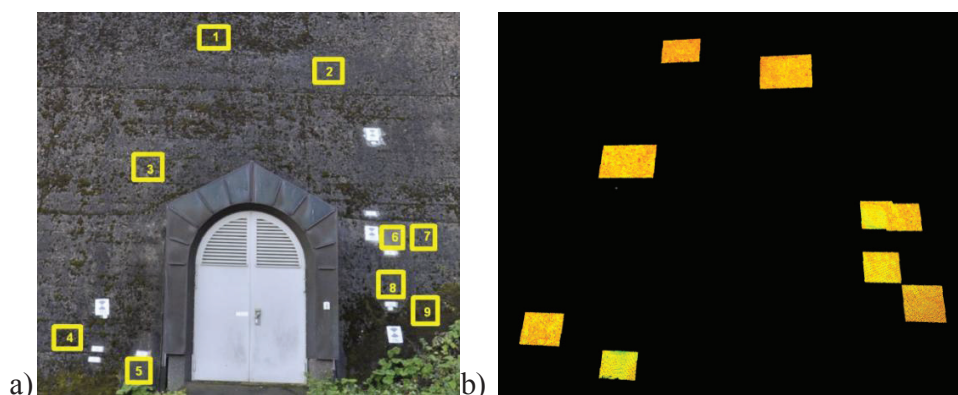
Figure 5: Reference fields Intensity images (with Leica C10, station 501): (a) reference fields marked on the concrete dam’s wall and (b) image of intensity of the reference fields.

Reference fields for surveyed surfaces were selected (Fig. 5; Table 1). They were indicated during concrete strength measurements using Schmidt hammer, performed directly after laser scanner surveys.
