EXAMPLE BUILDING DAMAGE CAUSED BY MINING EXPLOITATION IN DISTURBED ROCK MASS

LUCYNA FLORKOWSKA

The Strata Mechanics Research Institute of the Polish Academy of Sciences,
ul. W. Reymonta 27, 30-059 Kraków, Poland.

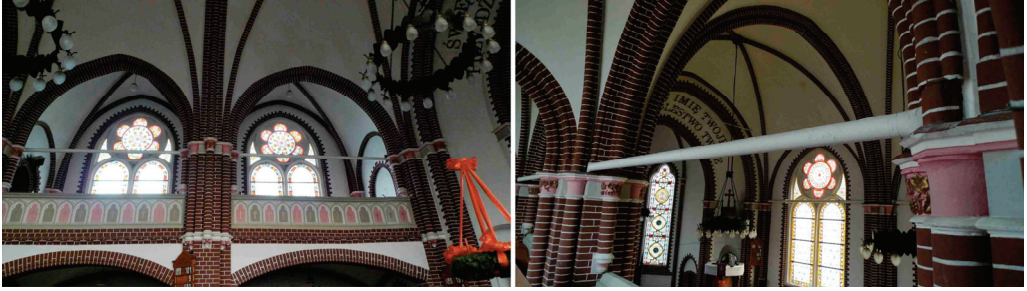
The system of tie-beams comprises: RC tie-beams, 60 cm below ground level, external steel tie-beams, 40 cm below parapets (mounted into wall chases) and presented in Fig. 3 and 4 steel tie-beams inside the church, in level with pillars' capitals. Steel tie-beams holding the structure from outside are circumferential (apart from low-installed fragments each side of presbytery housing the vestry) and anchored in the walls. Additional transverse anchoring is provided by steel tie-beam separating main nave from presbytery. The steeple is protected by steel anchor in Western wall and steel stretcher in Northern wall.

Fig. 4. Steel tie-beams protecting against mining damage
