TECHNICAL NOTE

EXAMPLE OF THE APPLICATION OF JET GROUTING TO THE NEUTRALISATION OF GEOTECHNICAL HAZARD IN SHAFT STRUCTURES

PIOTR DYBEL, DANIEL WAŁACH, JUSTYNA JASKOWSKA-LEMAŃSKA

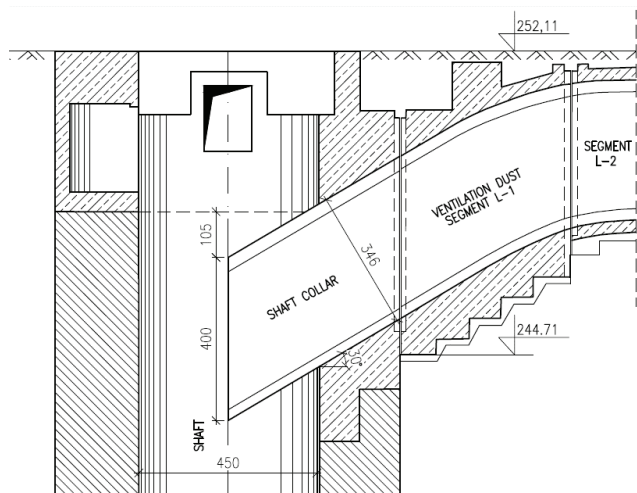
Fig. 1. Longitudinal section drawing of the ventilation duct and shaft collar

After the dislocation of the ventilation duct, a site inspection was performed, including the immediate area around the shaft, ventilation duct and the shaft top building. As a result of the displacement of the first segment of the ventilation duct in relation to the shaft collar, a possibility of additional loads affecting the shaft lining was found. These loads were not taken into account in the initial design. The research conducted by the authors included the analysis of the current condition as well as control static and strength calculations helped to assess the real hazard to shaft structures and infrastructure. It was shown that further subsidence of the ventilation duct may lead to damaging the shaft structures. Immediate protection of the

ventilation duct against further subsidence was recommended [2].

The diagnosed problems with uncontrolled subsidence of the ventilation duct required the development of a schedule of remedial measures for further safe operation of the shaft. Due to the closeness of the shaft lining, the works related to the reinforcement of the ground were performed using the jet grouting technology. The decisive factors in the selection of this technology were the quickest possible neutralisation of the hazard and a lack of additional negative impact on shaft lining.
