The Consequences of Non-Uniform Founding of Concrete Tank in Weak Wet Subsoil

Abstract: The article presents problem of non-uniform foundation of structures in weak wet subsoil. The problem is illustrated with the case study of two-chamber-reinforced concrete water tank constructed in 1920s of 20th century, which cracked during construction. Under part of foundation, where the peat was found, the concrete piles were introduced.

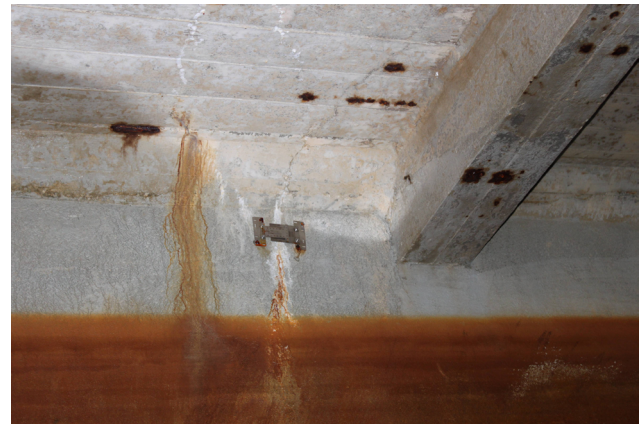
Figure 10: The crack width gauge fixed to the longitudinal partition wall.

The crack width was measured with eight crack gauges allowing to assess the changes in crack width as well as displacement along the crack (Fig. 10). The location of the gauges is shown in Figure 11. The measurement results are shown here as well. An analysis of the data from Figure 11 indicates that the crack measured with gauge No. 4 in the chamber No. 1 is immovable. The remaining cracks in this chamber show little changes in width (up to 0.2 mm). They also show very little displacement along crack (up to 0.05 mm), except the gauge No. 6 fixed next to longitudinal partition wall in the region with piles. This gauge was found to get displaced along a crack of 0.85 mm between 2016 and 2017. The crack width in chamber No. 2 changed to a maximum of 0.30 mm. The displacement

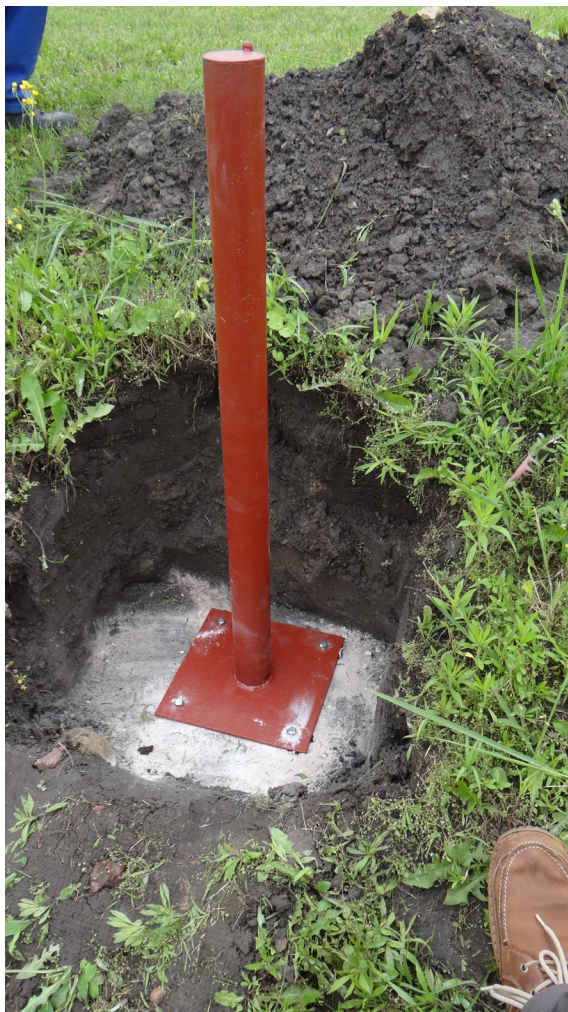
At the same time, the vertical displacement was measured. Nine controlled points were laid out on the upper surface of the tank roof slab along the axes of longitudinal walls. Their arrangement is shown in Figure 11. Owing to the fact that the tank was covered with embankments, special structures constituting the control points were designed. They were fixed to the roof slab and protruded over the embankment (Fig. 12). This enabled a direct measurement of control points without roof slabs uncover.

Figure 12: The structure of controlled point whilst fixing to the upper surface of the roof slab.
