REDUCTION OF DERIVATIVE PIPELINE EFFORT IN WATER TURBINE

Abstract: The article presents an approach to evaluate and reduce the effort of the derivative pipeline in a water turbine of a hydroelectric power station in its vulnerable spots. Potential places of the biggest effort of the structure, as well as the coefficient of displacement and safety factor related to them were identified using FEM numerical method. Pipeline reinforcement was designed and made based on FEM analysis and non-destructive tests.

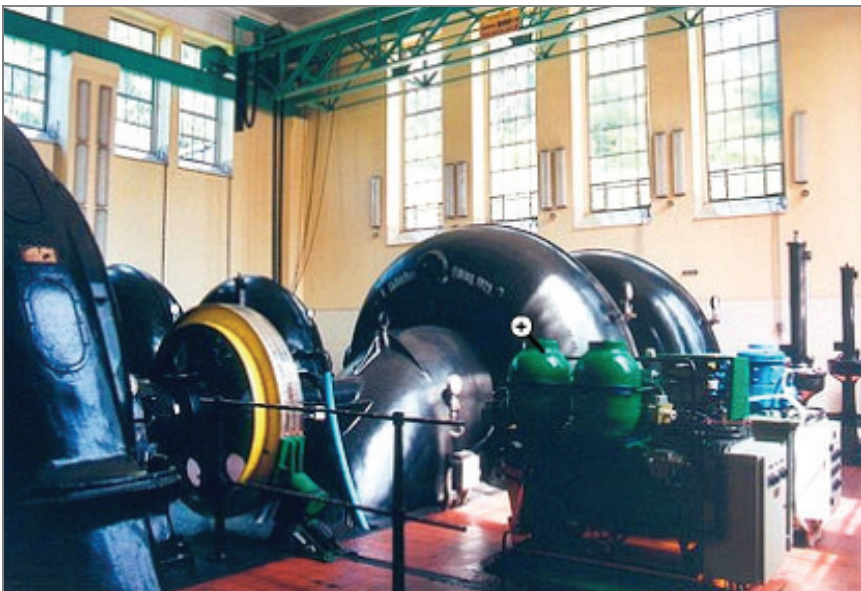
Fig. 1. View of water turbine generators in Łapino.
Source: <http://energia-hydro.pl/2,26,0,Galeria-Lapino.html>

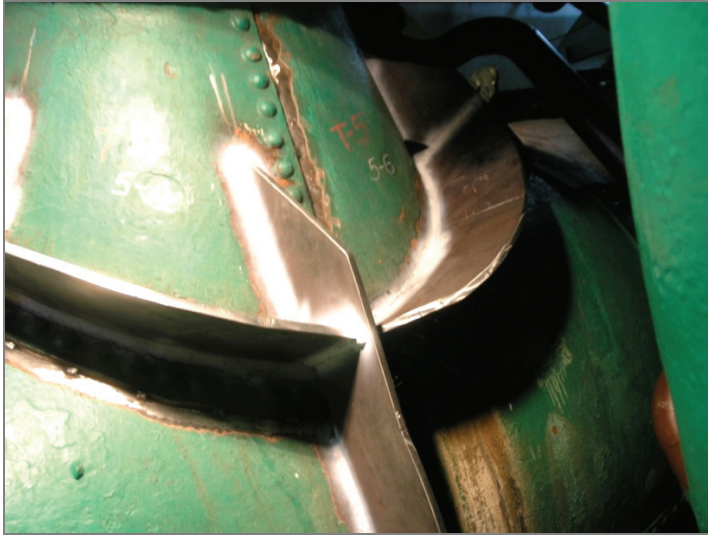
Using the knowledge concerning existing solutions (Fig. 12) designed by the authors, the computer simulation was used again and multiple alternatives were examined to match an optimal way to reinforce the pipeline. The calculations were carried out for the pressure of 0.21 MPa at failure state until the achieved value of the reduced stress was below the yield strength.

Fig. 12. Similar solutions.
Source: prepared by the authors

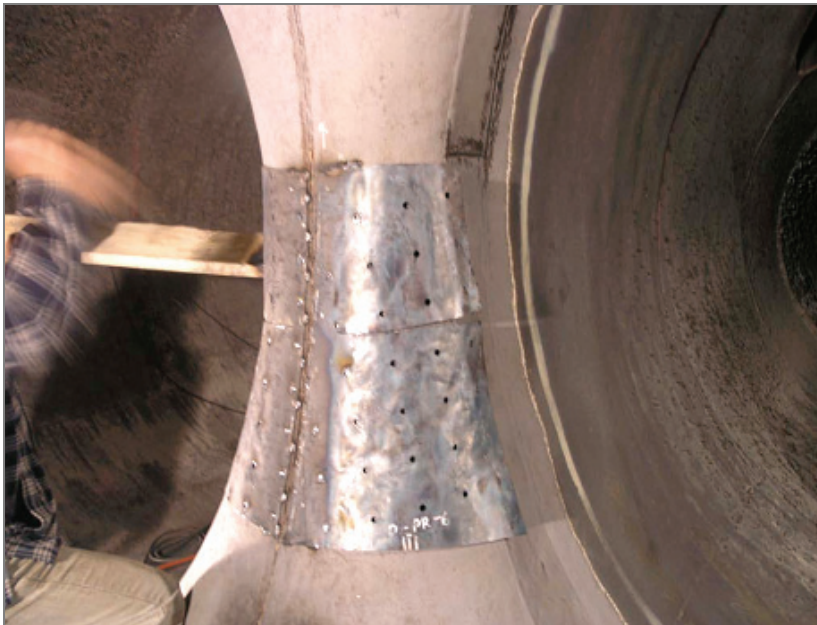
The assembly of the reinforcement components began from the central part (Figs. 16, 17). The reinforcement of the branch structure was divided into stages. First, the plating of the central part of the branch was laid, next the reinforcement plates of the bottom surface were laid symmetrically to the division plane. The last stage was creating the reinforced areas on the top surface of the branch. After careful fitting into the pipeline surface, each component was joined with tack welds along its perimeter, the plug welds were also made.

Fig. 16. Quadrangular components of the reinforcement in the process of tacking along centerline of the branch.

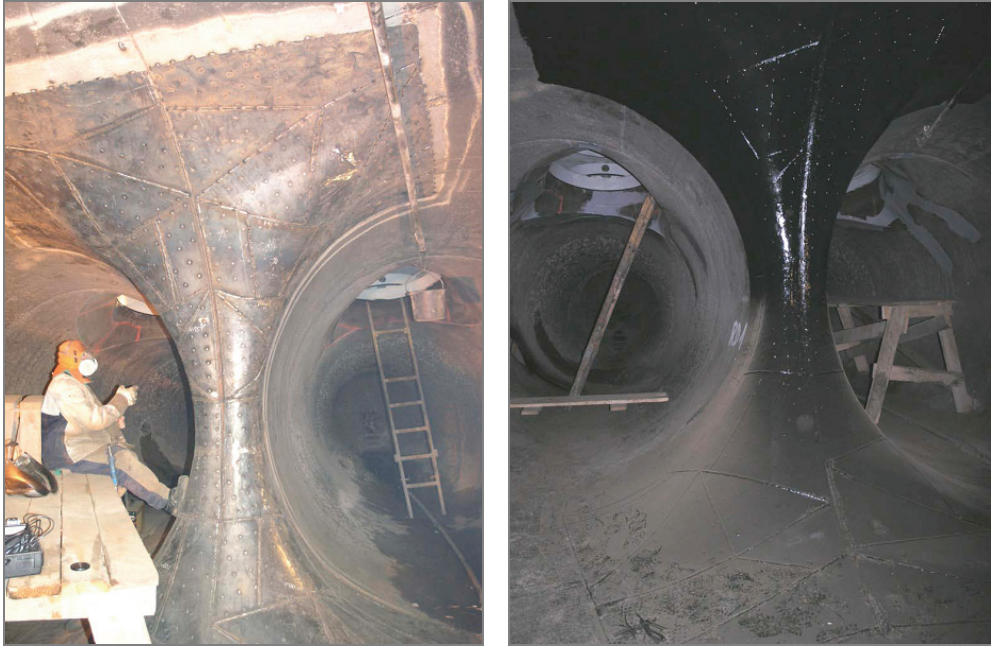
Fig. 17. Structure welding of the reinforcement components to the coating of the pipeline branch and the completed painted plating of the pipeline branch.

The next stage comprised of depositing circumferential fillet welds which joined three components simultaneously: adjoining edges of reinforcement components with pipeline coating, MAG welding process and 1.0 mm diameter solid wire with Ar + CO₂ gas shield were used.
