HORIZONTAL DRAINS AS EFFECTIVE MEASURE FOR LANDSLIDE REMEDIATION

MILOSLAV KOPECKÝ, MARTIN ONDRÁŠIK, DARINA ANTOLOVÁ

Faculty of Civil Engineering, Department of Geotechnics, Slovak University of Technology,
Radlinského 11, 813 68 Bratislava, Slovakia.

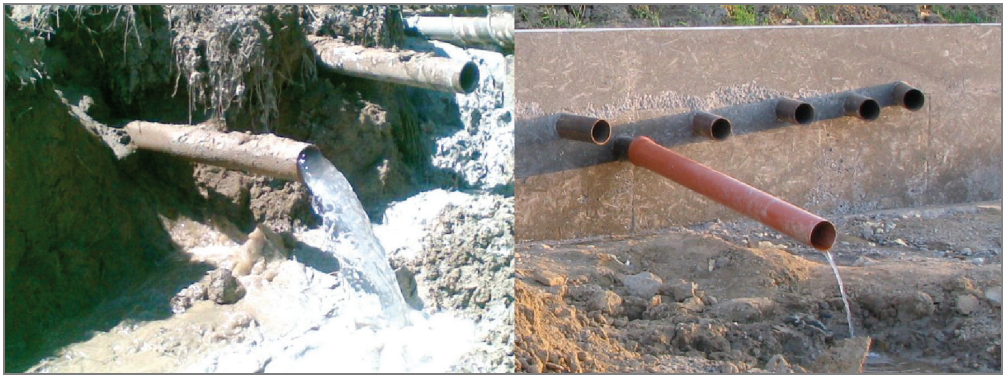
Fig. 3. HDB discharge during drilling and two months after

The largest discharge from HDB is achieved during drilling (max. 300 l.min⁻¹), or shortly after, and then the discharge has declining trend (Fig. 3). The initial large discharge is mostly because of static groundwater reserves. Water from rainfalls is not a sufficient source to recharge larger dynamic resources. HDB discharge more water from the landslide than a volume of inflowing groundwater is recharging it. The further decrease of the discharge with time is also caused by the slow clogging of the casting perforations (Section 6).

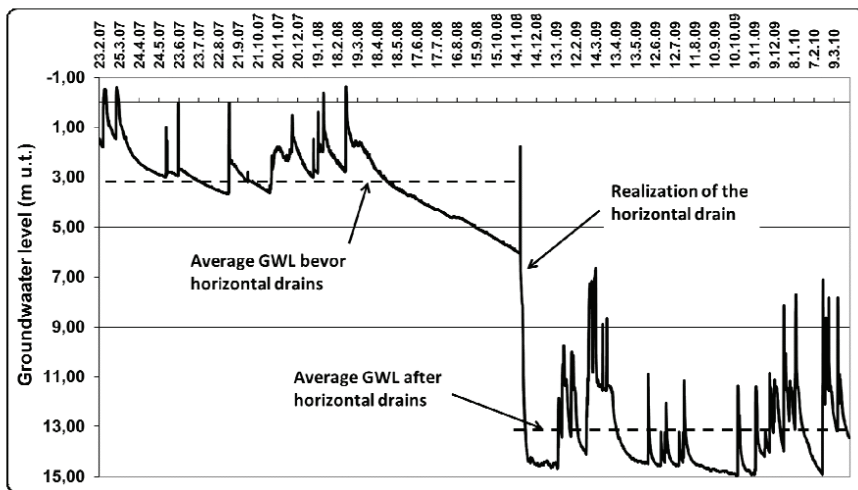
Fig. 5. Example of a decrease of GWT in observation well after the HDB realization

stability can be evaluated indirectly, in particular by changes in hydraulic potential and its gradient, changes in pore pressure or, in the simplest case, changes of groundwater tables (Fig. 5). The direct effect can be evaluated by various methods of movement measurements at the surface or in the body of a landslide.

In Fig. 5, there is an example of groundwater table (GWT) decrease measured in observation well with a continuous sensor which was set to one hour reading period (locality highway rest area in Považská Bystrica). The average decrease of GWT in observation wells after realization of HDB was almost 10 m, which resulted in a slowdown, respectively stopping of the landslide motion as proved by measurements in the nearby inclinometer. The overall decrease of GWT in the landslide area under the highway rest area after realization of 41 HDB with total length of 3 572 m was 10 to 12 m in comparison to original state of GWT [8 and 9].

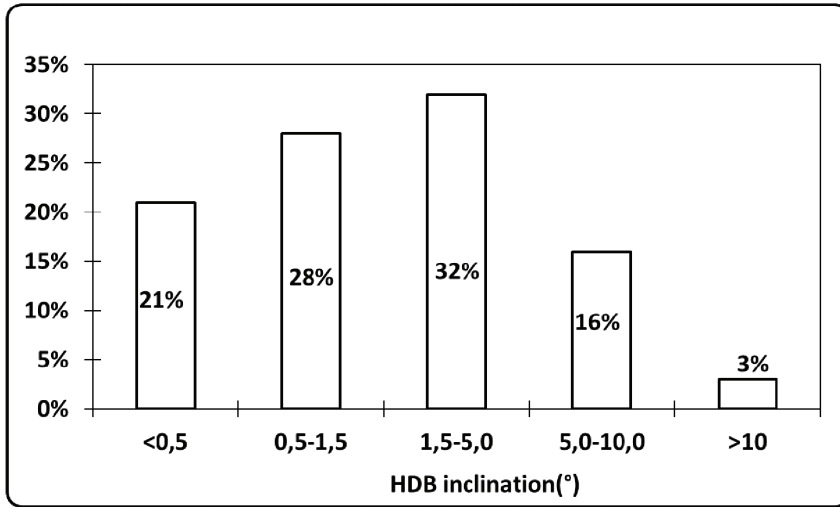
Fig. 7. Proportion of functional HDB based on their inclination

Distribution of boreholes according to the inclination is illustrated in Fig. 7.

81% of functional HDB has inclination up to 5° and only 3% of HDB has inclination over 10°.

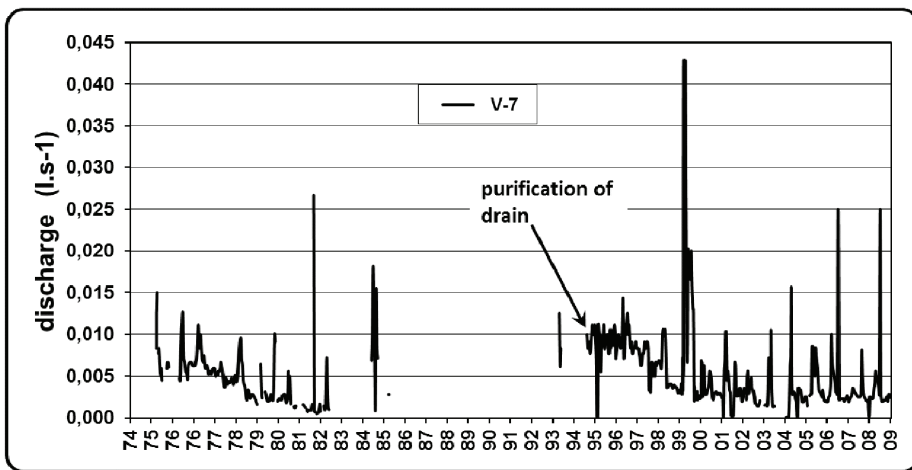
Fig. 10. Recovery of discharge on HDB V-7 after its cleaning in 1995

After 15 years in operation the cleaning confirmed to be very successful in three horizontal boreholes V-7 (Fig. 10), V-23 and HV-10. Significant result of the cleaning was observed also in the HDB HV-11. The result of cleaning effectiveness on the other HDB could not be unambiguously determined.

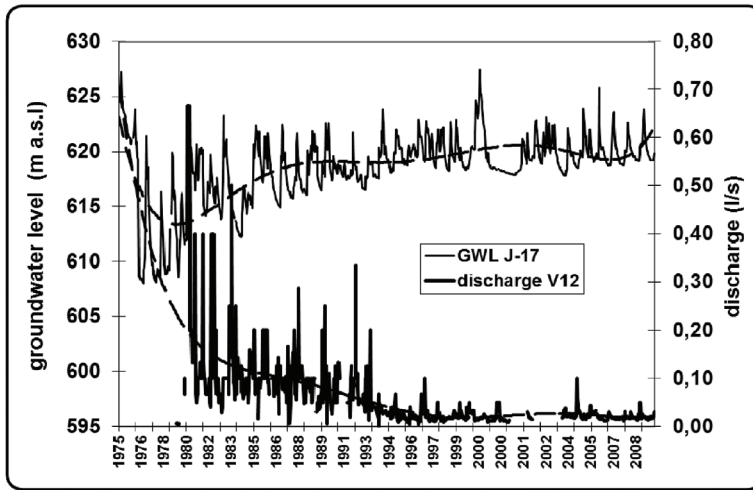
Fig. 11. A decrease of functionality of HDB V-12 and GWT rise in observation well J-17

However, there is obviously a negative effect of the decrease of discharge rate in HDB from V-12 to V-15 situated in the main crown area of the landslide (Fig. 8), where there is a long term increase of GWT in observation wells J-16, J-17 (Fig. 11), J-18 J-11B as well as J-11 – where groundwater is flowing out from a vertical borehole head as from artesian well [12].
