# FRICIONAL CHARACTERISTICS OF GEOSYNTHETIC–GEOSYNTHETIC AND GEOSYNTHETIC–SOIL INTERFACES DETERMINED BY THE INCLINED PLANE APPARATUS

DAMIAN RZEPECKI

JEAN-PIERRE GOURC

EUGENIUSZ DEMBICKI

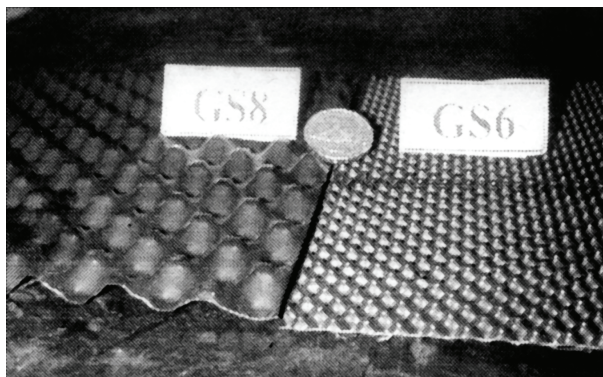
Fig. 8. The geospacers

density polyethylene geomembrane (HDPEgm) or a high density polyethylene geospacer (gs6) has been used as the lower geosynthetic. The geospacers were of the same shape concept but their thickness was different (Fig. 8).

1. non-woven non-reinforced geotextile – gts (Fig. 9);
2. non-woven geotextile, reinforced with polyester fiber – gtxR (Fig. 10);
3. woven geotextile, reinforced with black polyester fiber – gtxRblack (Fig. 11);
4. woven geotextile, reinforced with blue polyester fiber – gtxRblue (Fig. 12);
5. geospacer – gs6 (Fig. 8);
6. geospacer – gs8 (Fig. 8);
7. geomembrane – PVCgm
